FINAL REPORT

FIELD STUDY OF A SHREDDED-TIRE EMBANKMENT IN VIRGINIA

April 2004
VTRC 04-R20

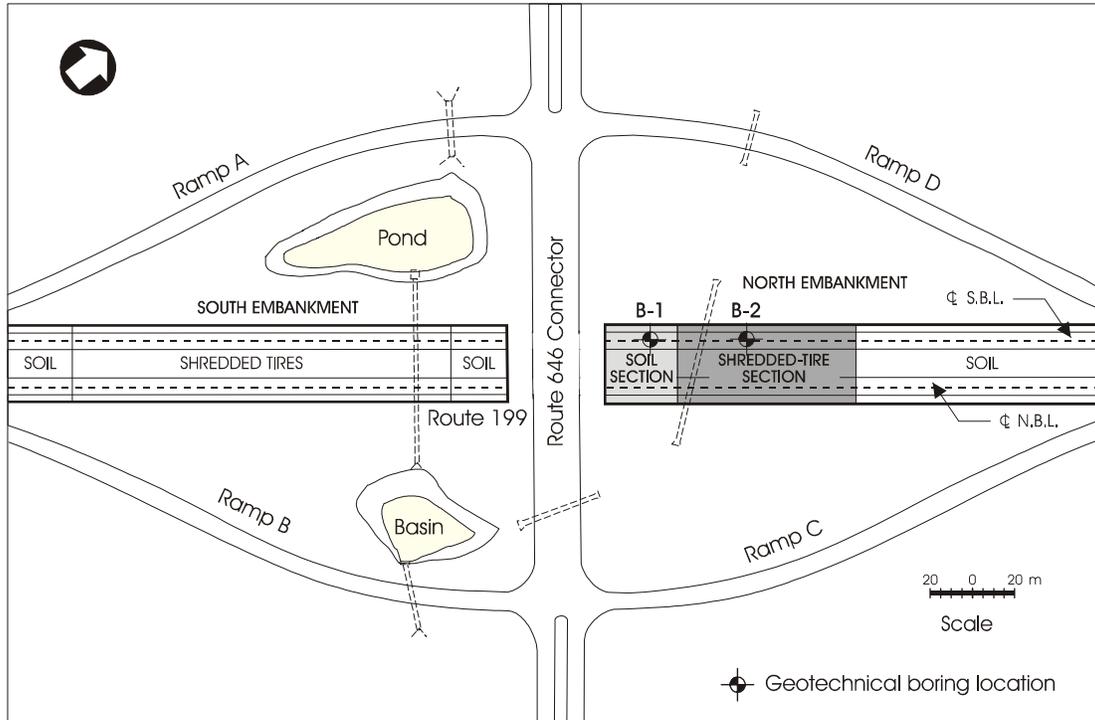
Figure 2. Project Layout and Borehole Locations

Geotechnical borings were drilled in the foundation soil before the embankment was constructed. Boring locations are shown in Figure 2, indicating the general layout of the project. Borehole logs are shown in Appendix A. These logs reflect non-uniform soil stratigraphy. The subsurface soil underlying the shredded-tire section (B-2) is more compressible than the soil underlying the conventional embankment section (B-1).

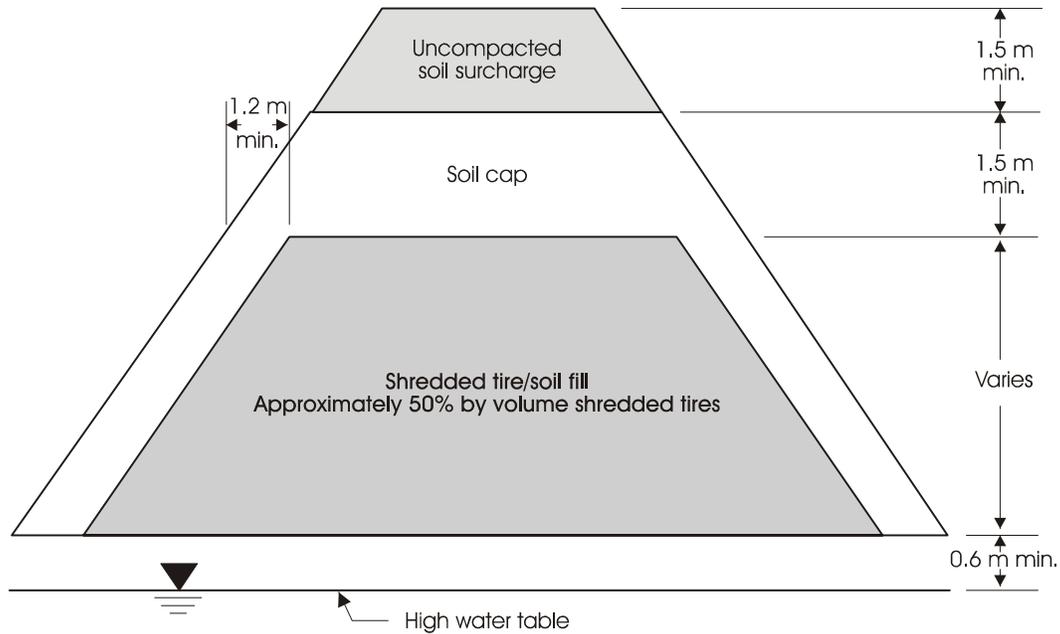
Figure 3. Embankment Cross Section

Two highway embankments were constructed in the summer of 1993 next to the Route 646 Connector, as shown in Figure 3. They contained shredded-tire sections adjoining conventional soil sections. Shredded-tire embankment sections were 80 m (260 ft) long and 160 m (520 ft) long in the north and south embankments, respectively. The maximum height of the shredded-tire section was approximately 6 m (20 ft).

Each embankment was terminated by a soil section approximately 30 m (100 ft) long to facilitate future bridge construction, linking both embankments over the Route 646 Connector. The bridge was scheduled for construction several years later.

Shredded-tire sections were built using an approximate 50/50 volumetric ratio (visual determination) of shredded tires to soil. The soil in the soil/tire mix in the north embankment was a yellow silty sand. The soil in the soil/tire mix in the south embankment was a red clayey silt. Tire shreds generally conformed to VDOT's Special Provision for Shredded-Tire Fills (Appendix B), which requires a maximum dimension of 25 cm (10 in), a maximum surface area of 260 cm² (40 in²), pieces having at least one sidewall severed, and no loose metal strands. Waste tires were shredded with steel cutting blades.

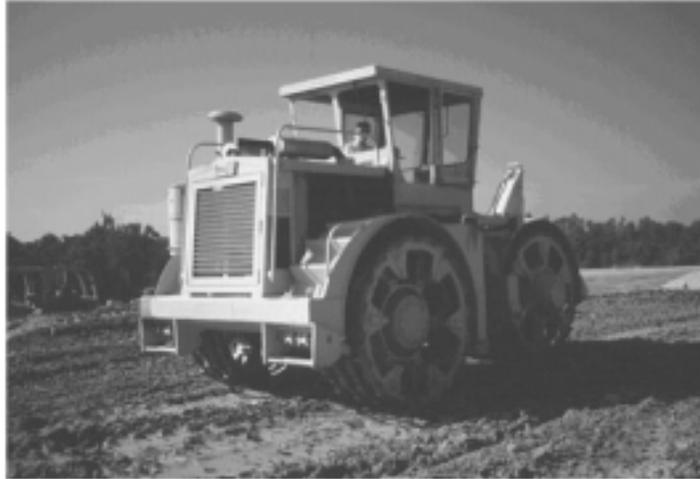
Figure 4. Compactor

Compaction control of shredded tire sections presented a unique problem. The use of a nuclear density gage or a sand cone was considered impractical, since it was impossible to conduct representative laboratory tests on small samples of soil/tire mix. To expedite construction, the researchers decided to control the process by monitoring the number of passes of a compactor. Based on field observations, a minimum of three passes of a segmented steel wheel roller, as shown in Figure 4, were required to compact each lift. The roller was a REX Model 3-55, weighing 26 tons, with a compactive effort of 2.3 MPa (335 psi). The same compactive effort was applied to the conventional embankment sections.

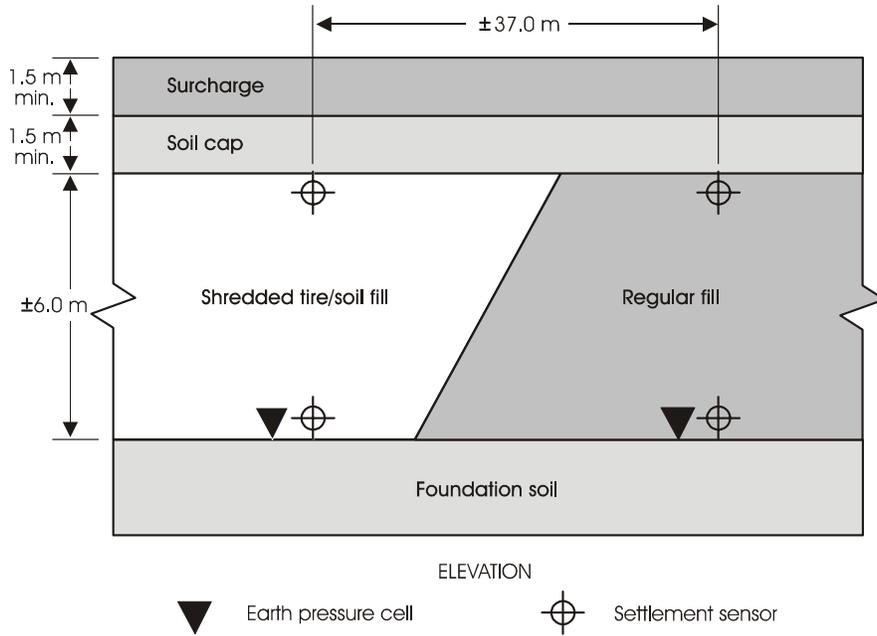
Figure 5. Embankment Elevation and Sensor Locations

Geotechnical monitoring instrumentation was installed in the shredded-tire and conventional embankment sections north of the Route 646 Connector. Settlement sensors were placed at the top and the base of the embankment. Earth pressure cells were installed at the base. Sensor locations and the instrumentation setup are shown in Figures 5 and 6.

Earth pressure cells, manufactured by Roctest, with a range of 340 kPa were used. In addition, Geokon settlement sensors (Model 4650-15V) were installed. All sensors were of the vibrating wire type. A Campbell Scientific CR-10 datalogger was used for data collection and storage. Data were retrieved periodically for analysis with a portable computer.

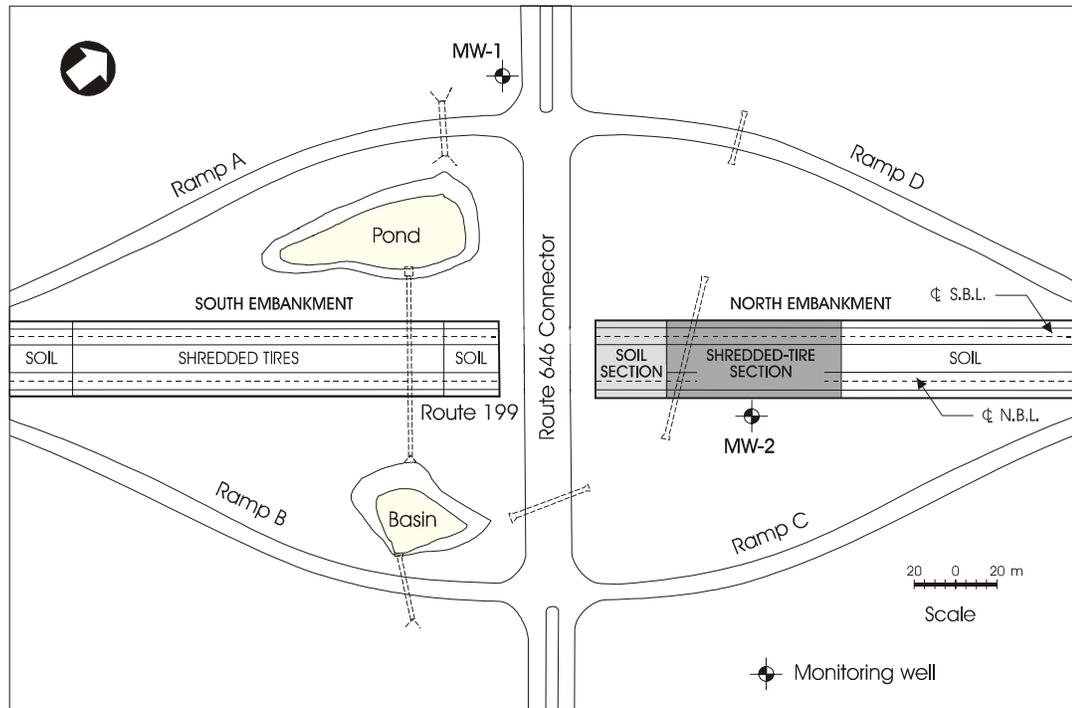
Figure 7. Location of Groundwater Monitoring Wells

The groundwater monitoring program was set up in accordance with the requirements stipulated in the Virginia *Solid Waste Management Regulations*.³ Two groundwater monitoring wells were installed, as shown in Figure 7. One well was placed at the toe of the shredded-tire section, and one background well was installed upstream. Wells were sampled at quarterly intervals for the first year and semiannually thereafter. The following elements were monitored: calcium, magnesium, sodium, chloride, iron, lead, zinc, hardness, pH, total organic carbon, total organic halides, and specific conductivity. Groundwater samples were chemically analyzed by a qualified commercial laboratory.

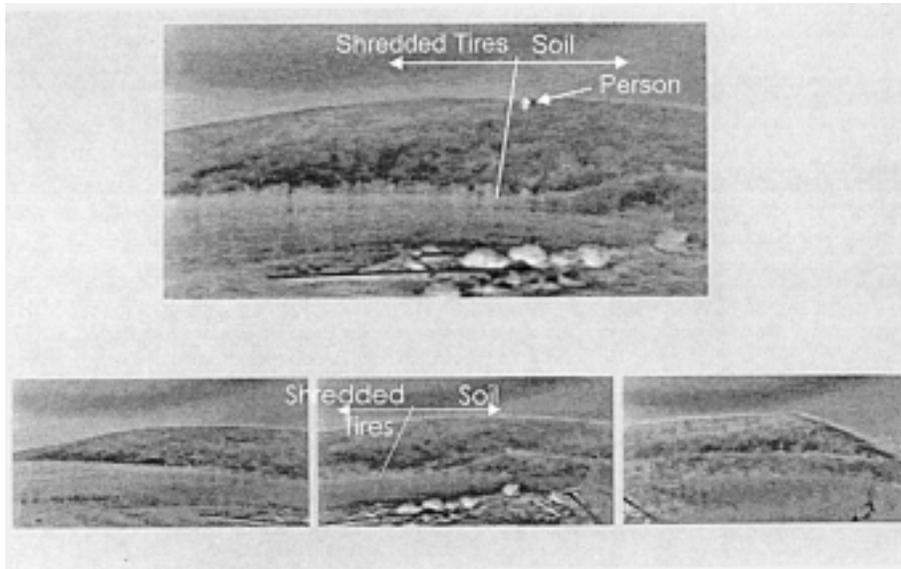
Figure 8. Infrared Scan of North Embankment

Additional temperature monitoring was conducted in May 1996 with a thermal imaging camera. Infrared side scans were taken along the north and south embankments. An infrared scan of the north embankment is shown in Figure 8.

The results of temperature monitoring indicated no evidence of any localized heat generation within the core of the shredded-tire embankment. This is significant in view of the problems experienced elsewhere.⁴ It is likely that the use of relatively large tire shreds intermixed with soil fill minimizes the potential for an exothermic reaction. There are no reports of problems with similar designs in other states to date. No signs of exothermic reaction were detected in the embankment during the 10-year monitoring period.

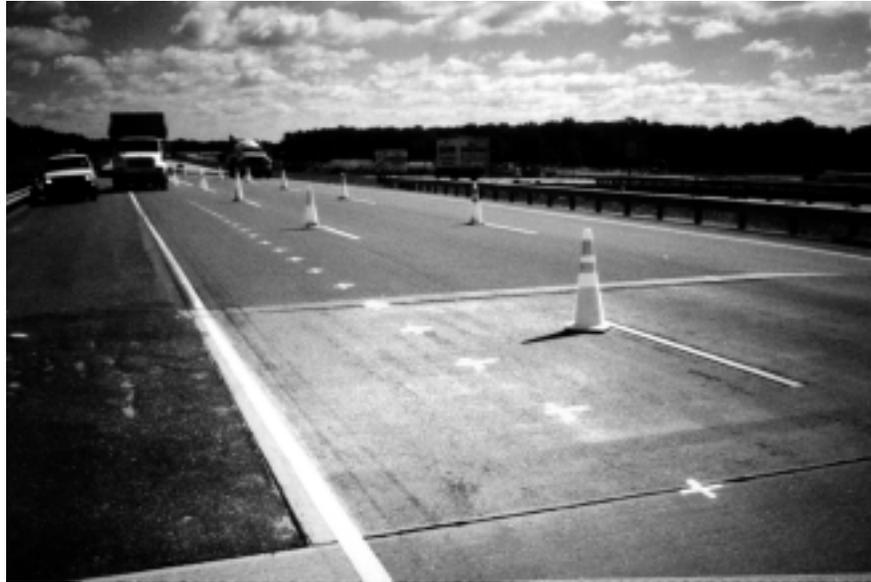
Figure 9. View of Bridge Approach

Elevation readings were taken on the approach embankment (top of pavement) annually between June 1999 and May 2003. The first set of readings was collected approximately 1 week before the road opened to traffic. Points were selected 1.5 m (5 ft) apart in the travel lane of Route 199, as shown in Figure 9. Figure 10 shows the resulting elevation profile, starting at the edge of the bridge deck and terminating 30 m (100 ft) beyond, for the north embankment. The first 6 m (20 ft) represents the approach slab. The shredded-tire embankment section begins approximately 21 m (70 ft) from the bridge backwall.

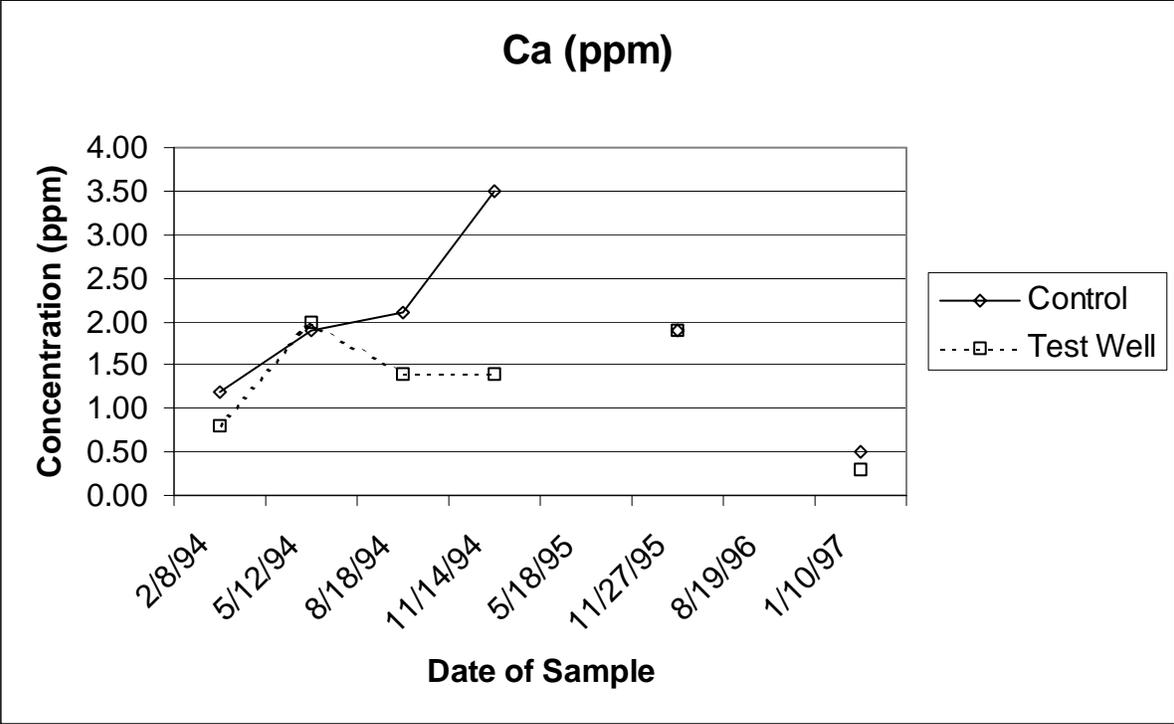
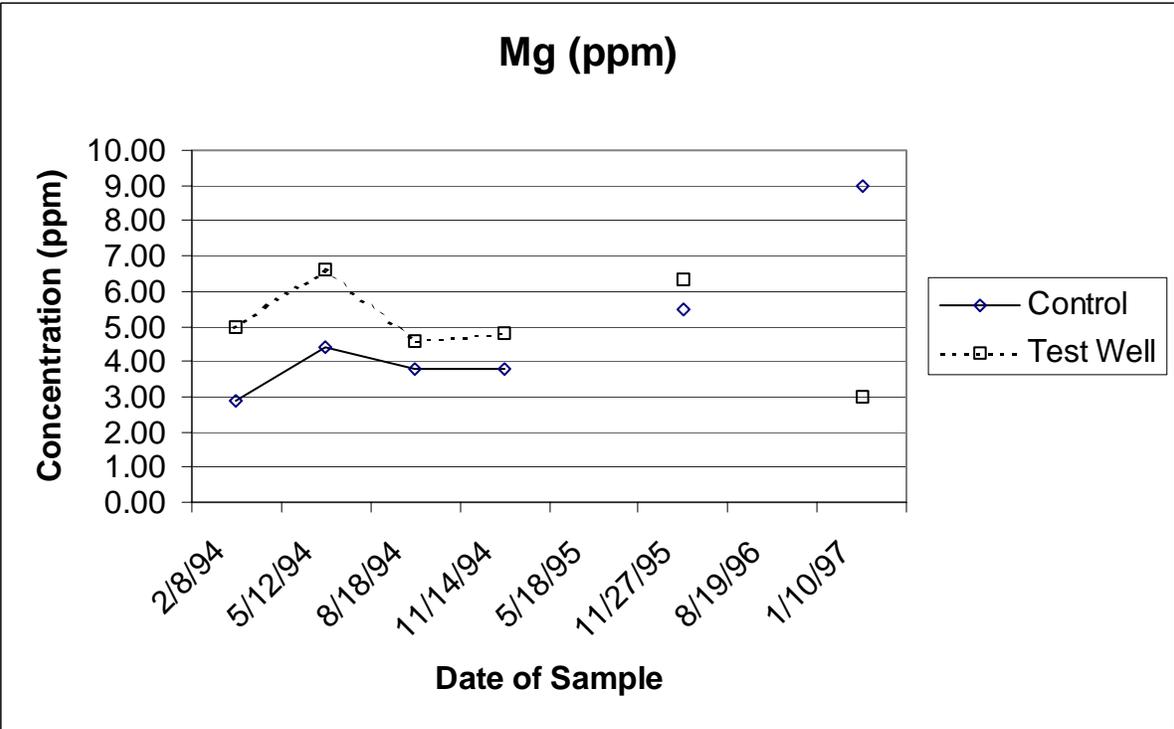
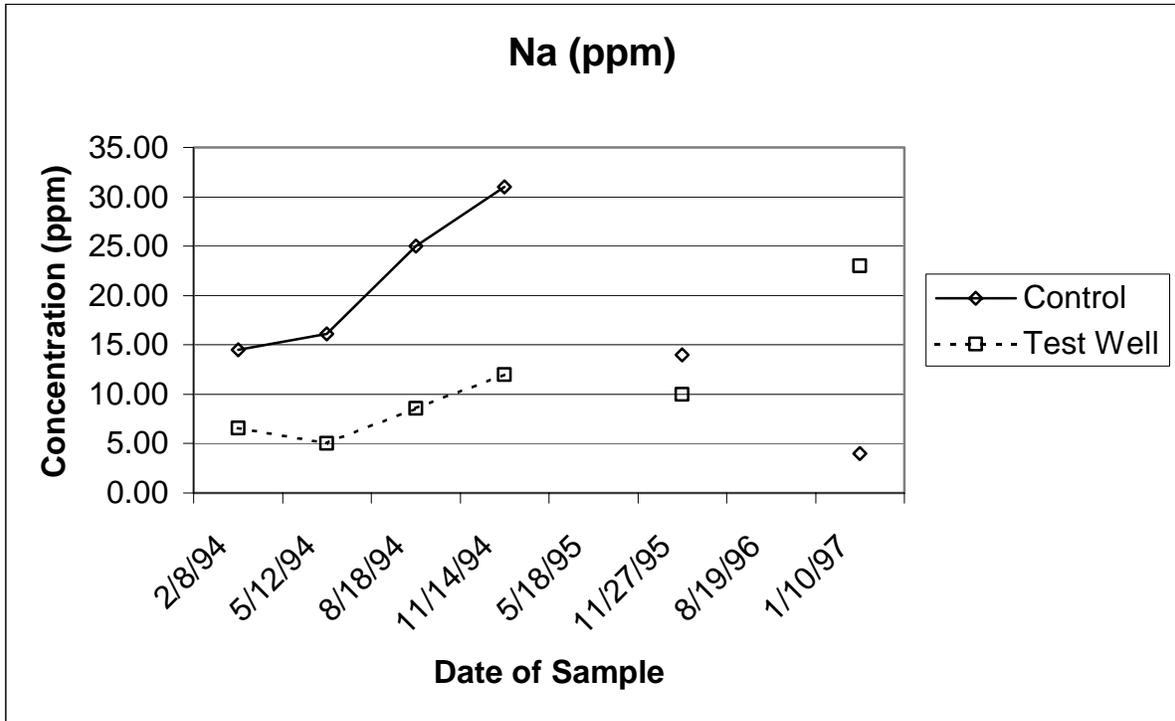
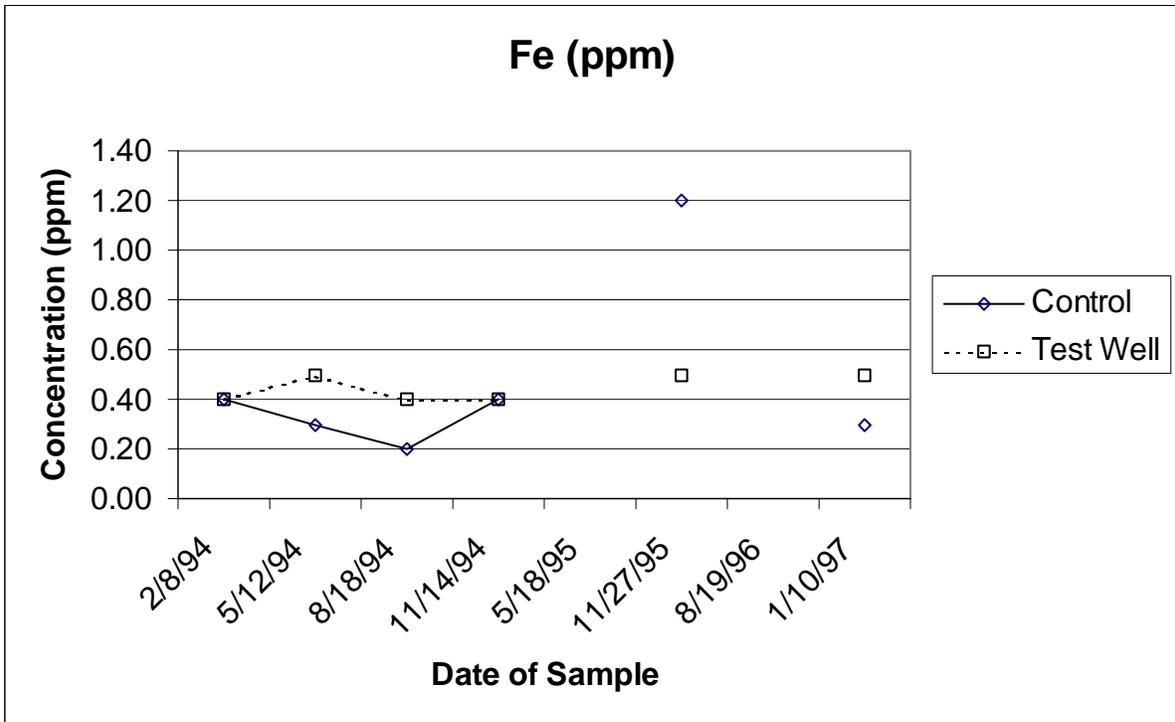
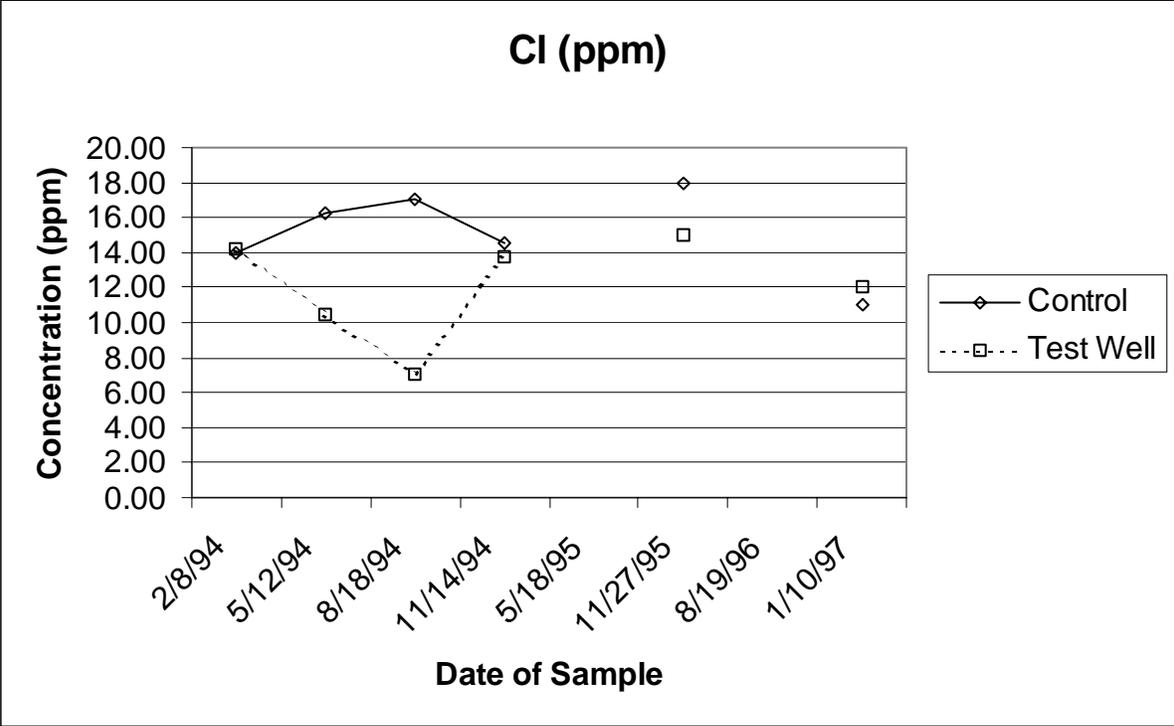
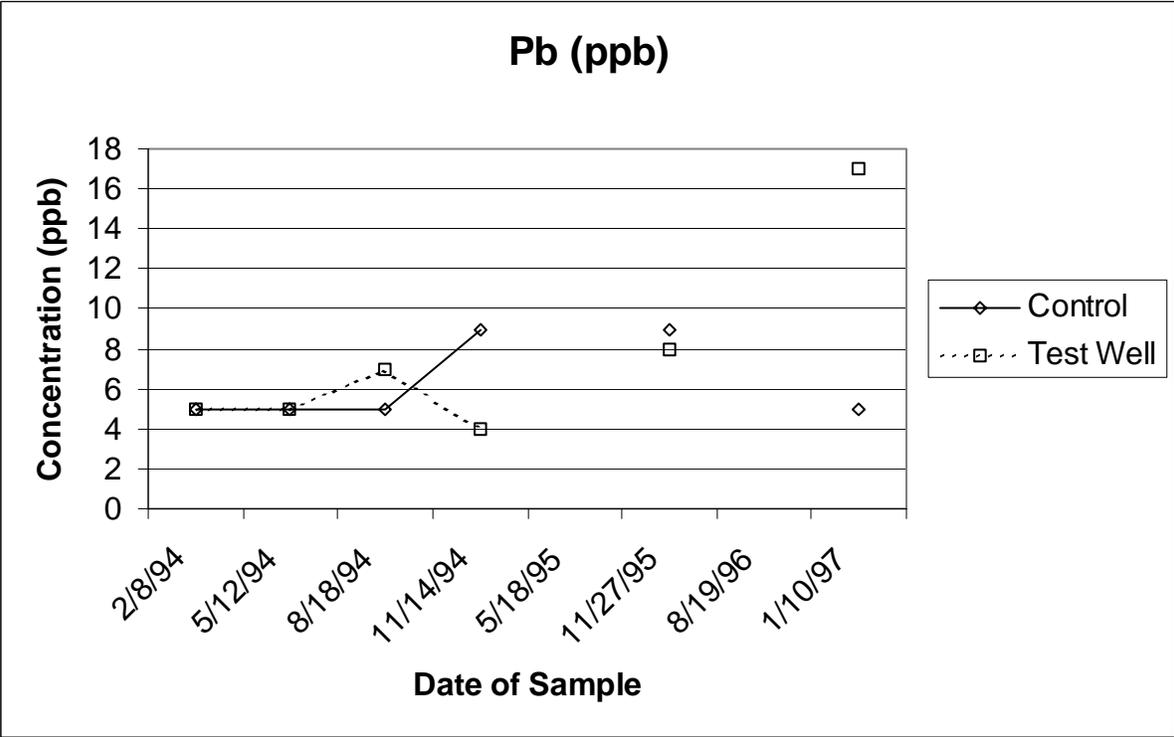
TIRE FILL GROUNDWATER SAMPLING DATA GRAPHS

Eight sets of water quality samples were taken during the monitoring of the shredded-tire embankment following construction. The list of elements selected for testing was compiled in accordance with the requirements of the Virginia *Solid Waste Management Regulations*.³ Groundwater samples were analyzed for the presence of calcium, magnesium, sodium, iron, chloride, lead, zinc, hardness, pH, total organic carbon, total organic halides, and specific conductivity. Raw sampling data are presented in Appendix C. The results are shown graphically in Appendix D. Groundwater samples were collected from February 1994 to January 1997. The monitoring wells were destroyed in 1997 during the construction of approach ramps to the Route 199 embankment.

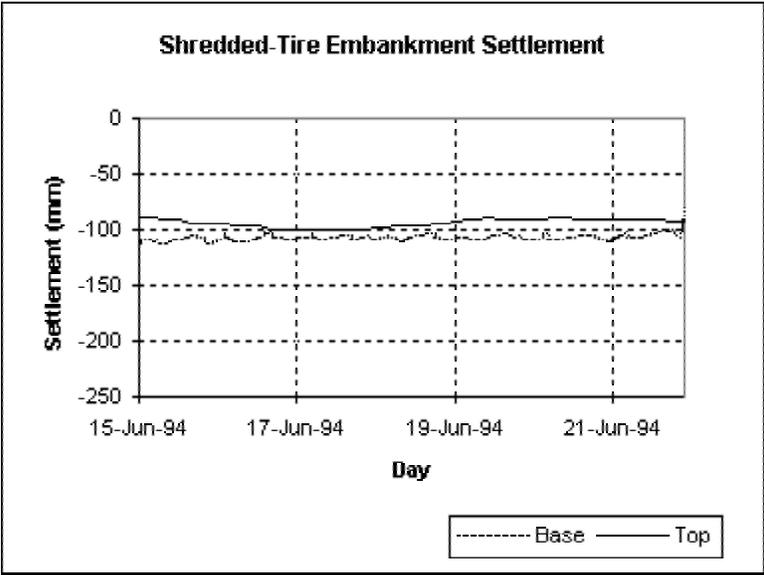
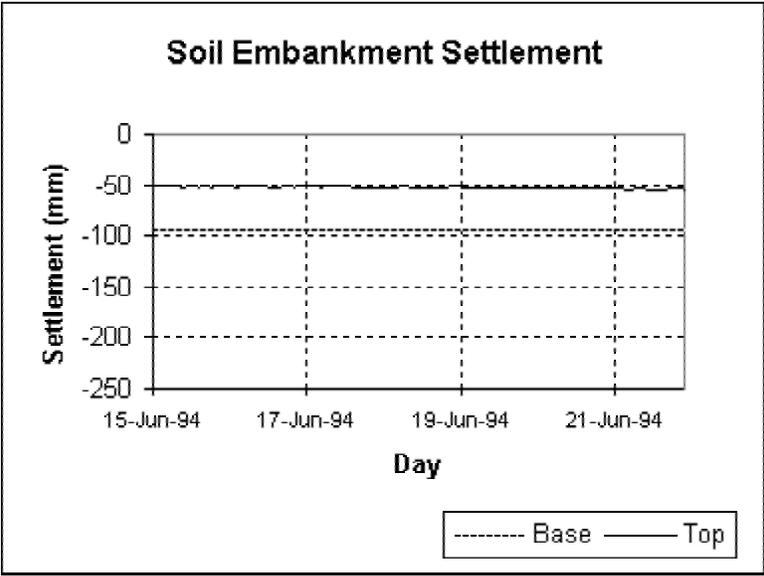
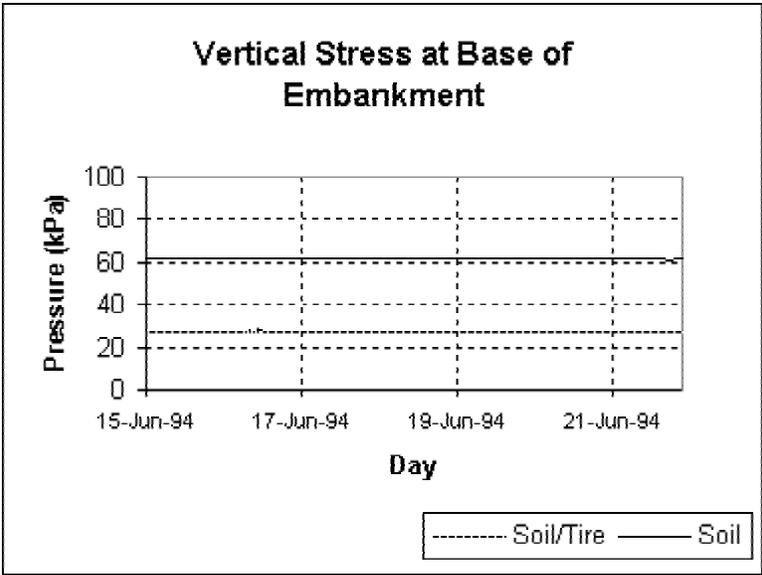
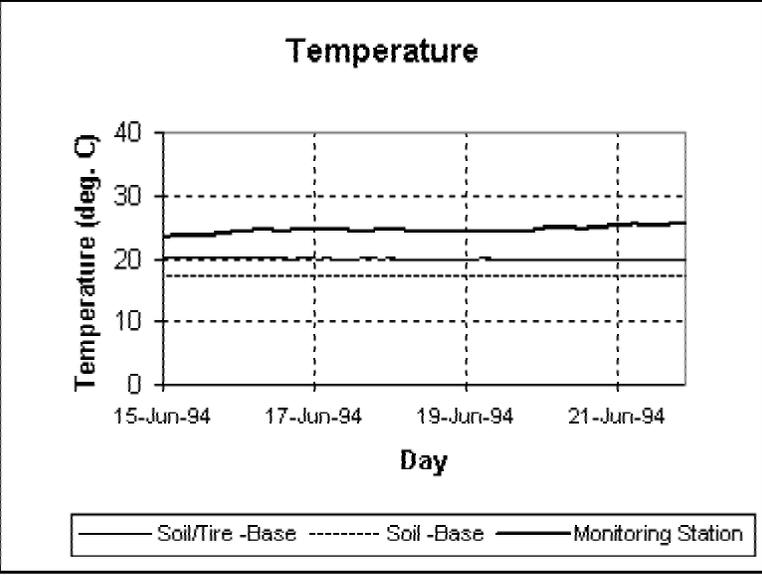
EXAMPLE OF SENSOR READINGS: JUNE 1994

In December 1993, approximately 4 months after construction, the tops of the embankment settlements were 52 and 30 mm (2.0 and 1.2 in) at the shredded-tire and soil sections, respectively, indicating a 1.7 ratio. The settlements were relatively steady in July 1994 at approximately 105 and 55 mm (4.1 and 2.2 in) for the shredded-tire and soil sections, respectively, indicating a 1.9 ratio. The settlement readings became erratic at the end of July 1994, rendering subsequent data unreliable. An example of pressure and settlement sensor readings collected in June 1994 is shown in Appendix E.
